# UNDERWATER BRIDGE INSPECTION REPORT

STRUCTURE NO. 66520  
TWNS NO. 51 (220<sup>th</sup> STREET)  
OVER THE  
STRAIGHT RIVER  
DISTRICT 6 - RICE COUNTY

PREPARED FOR THE  
MINNESOTA DEPARTMENT OF TRANSPORTATION  
BY  
COLLINS ENGINEERS, INC.  
JOB NO. 5221

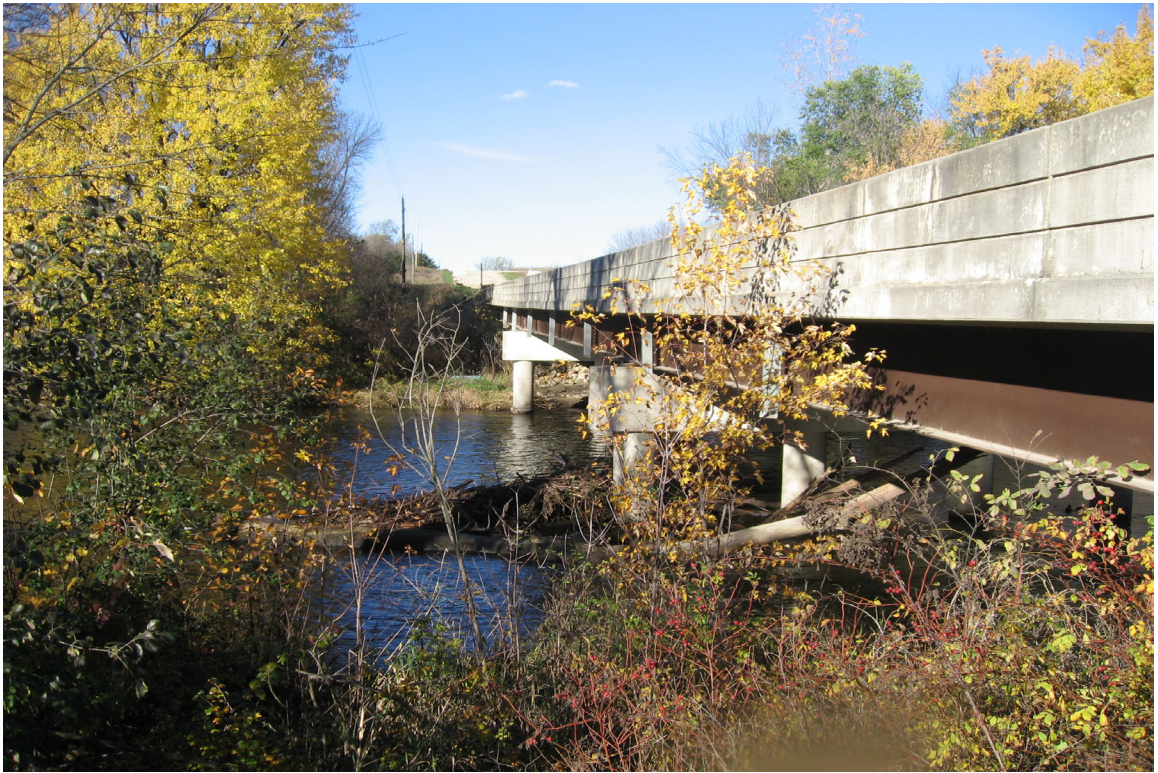
Photograph 1. Overall view of the Bridge, Looking West.

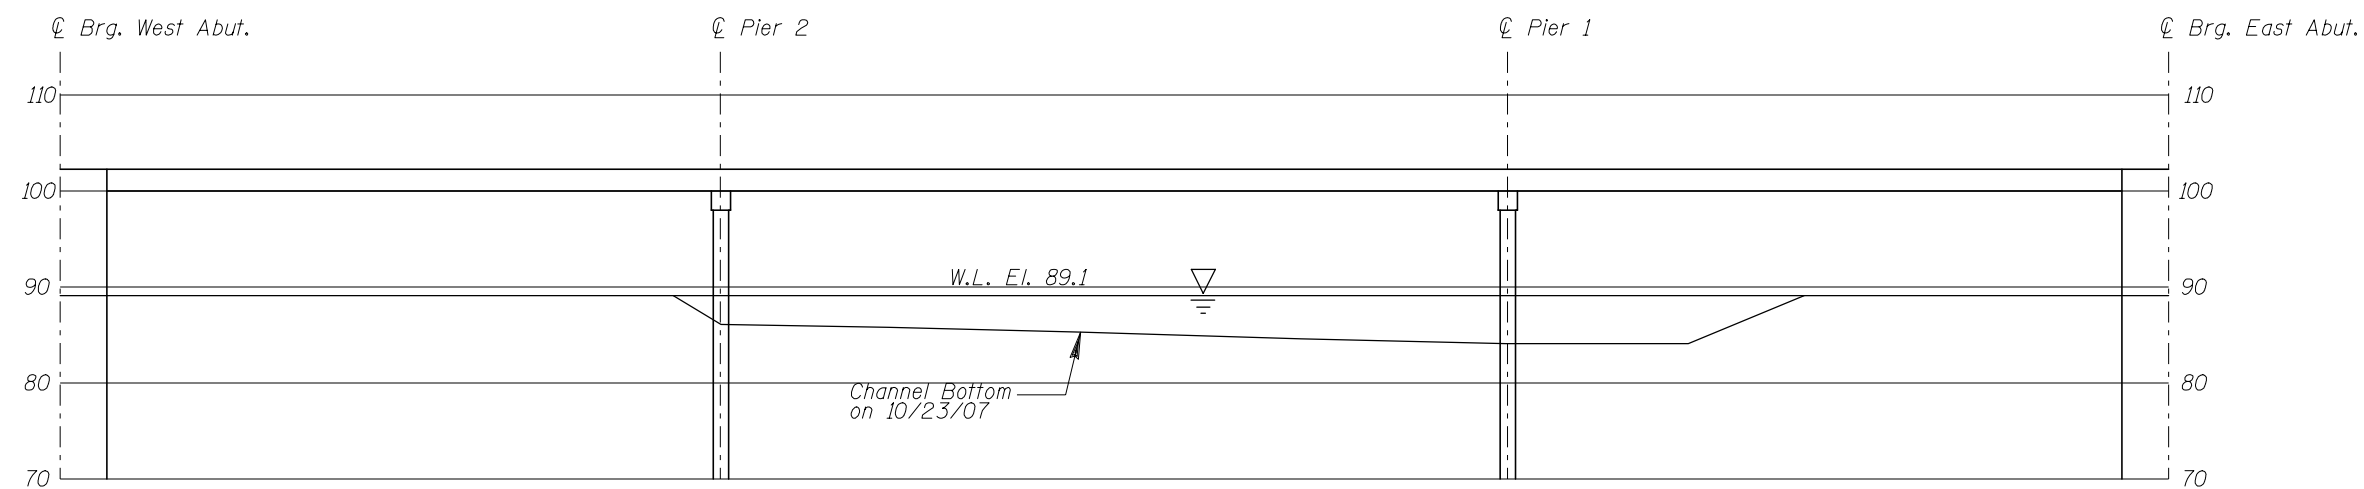
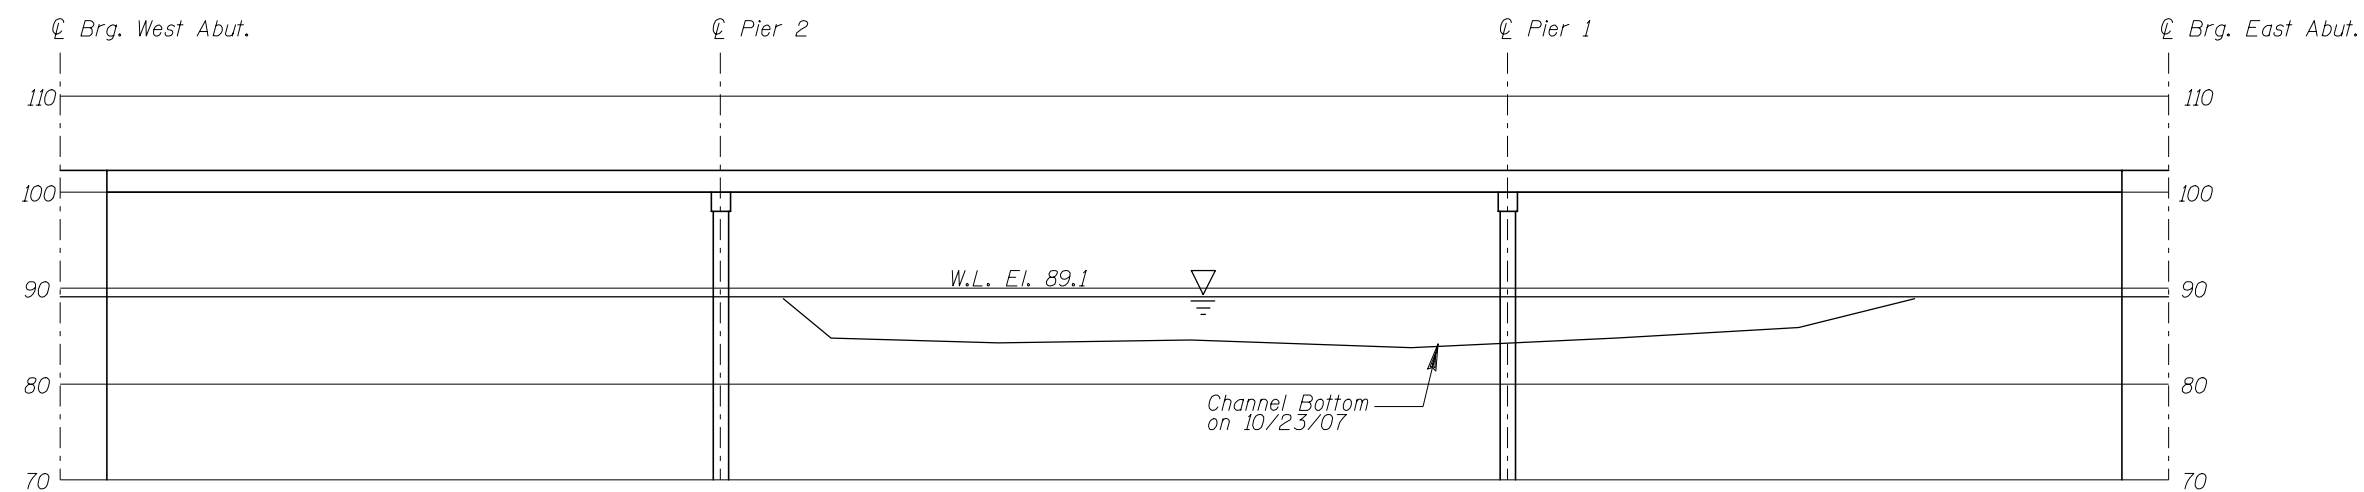
**INSPECTION AND SOUNDING PLAN**

- 1 A heavy accumulation of 2-foot-diameter and smaller timber debris was observed at the two upstream columns and the downstream column of Pier 1 that extended from the channel bottom up to 3 feet above the waterline.

- 4 The channel bottom at Pier 1 consisted of bedrock at the upstream and downstream columns with up to 2 inches of gravel and soft silt infilling along the middle columns. Minimal probe rod penetrations overall.

- 5 The channel bottom at Pier 2 consisted of rock and gravel with no probe rod penetration.

- (A) The heavy accumulation of timber debris at Pier 1 should be removed during routine maintenance.
- (B) Reinspect the submerged substructure units at the normal maximum recommended (NBIS) interval of five (5) years.
